INSPECTION REPORT: 00-295A

October 15, 2003

M/V "LEON I"

Inspect topping wire for deficiencies
and ascertain location of break caused during
accident on board the M/V "Leon I"
July 29, 2000

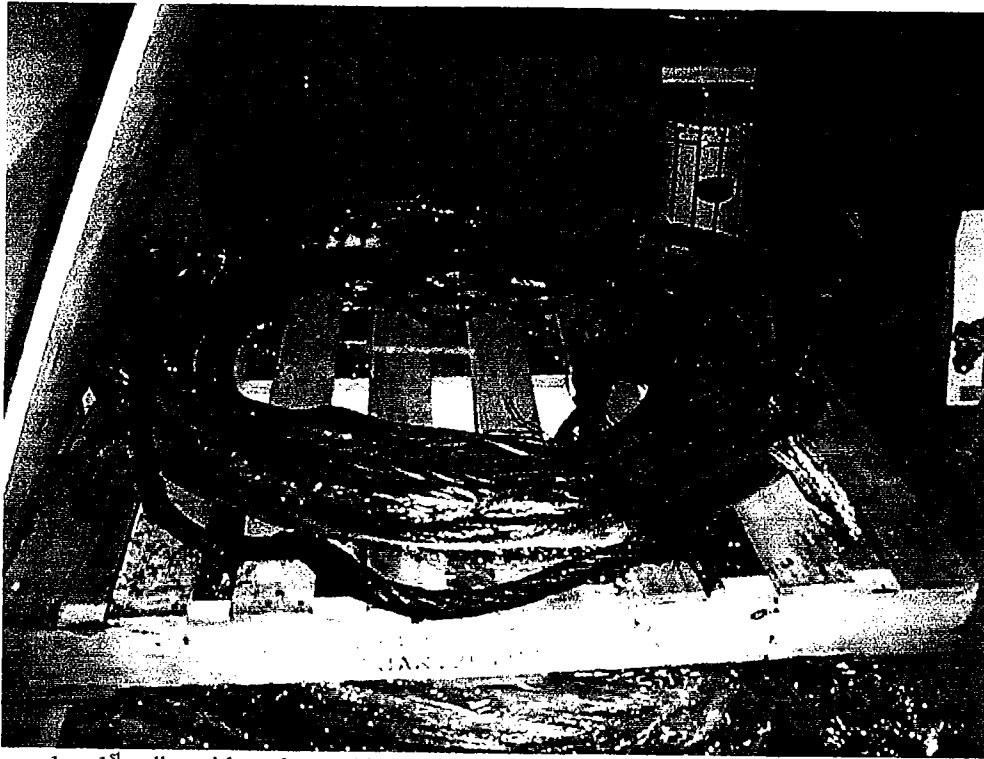
- 1a. First pallet- containing 2 sections of wire:
 - Socket end, that had originally been secured to boom top – was completely run out with socket remaining secured to pallet. (Total length of wire on pallet: appr. 115' 9")

1. 1st pallet with socket and broken end.

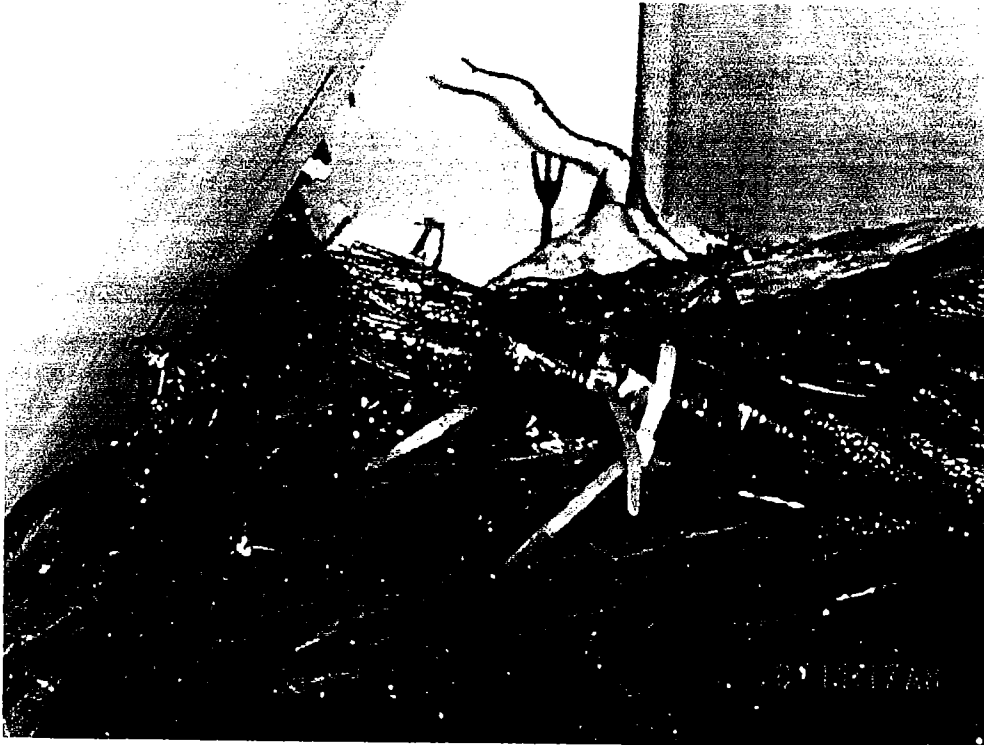
- 37' 02" from 2nd break wire was found with cut end; cut end strands were slightly opened up and end held together by musing wire.
- 1b. 11' wire section, that had one end cut, (by USCG) provided with electrical tape and one plastic band on cut end. Opposite end was found unraveled with strands torn. (Break caused during accident)

2. Short piece is wire section were USCG took sample for testing purposes. This short end was provided on one end with electrical tape and one plastic band and on opposite side had strands opened up and torn..

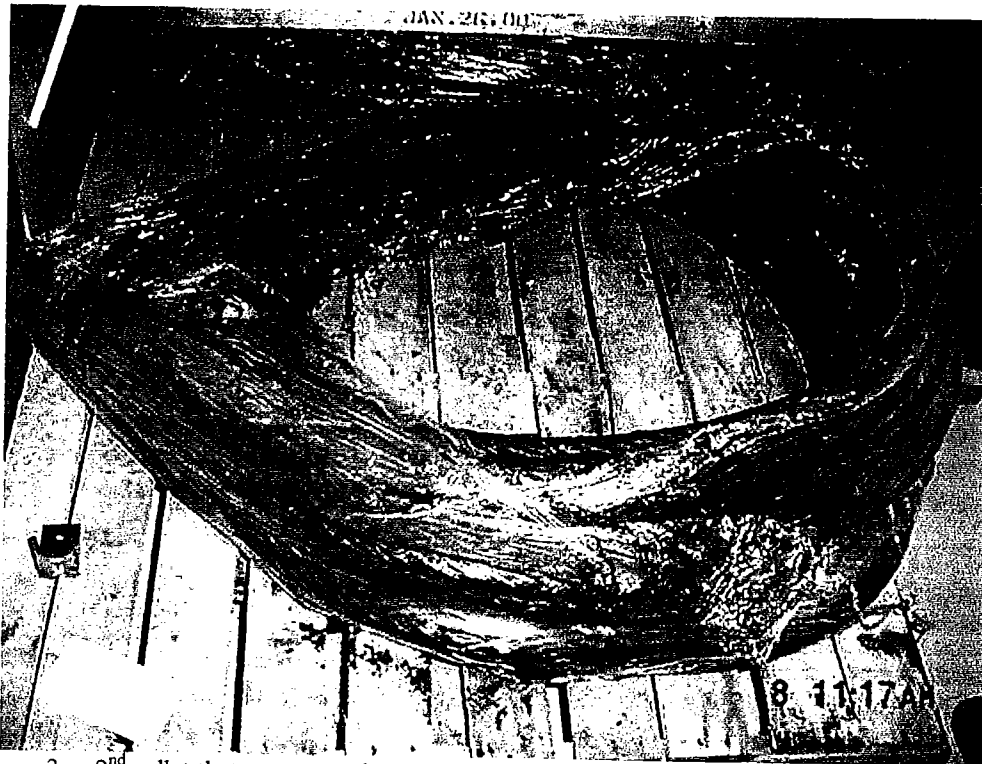
- 2b. 11' 08" wire section(cut at time of removing wire from vessel) -one end opened up and opposite end with end cut- matching end of 1st wire. (Musing wire had been placed on cut end.)

3. 2nd pallet that was opened up and partially uncoiled, was stacked with midsection of topping wire and one short piece. (CED had cut short piece at time of removing wire from crane drum and it matched cut end from long wire on pallet one. Short section was provided with cut end secured by musing wire and opposite end opened up and torn matching short piece from pallet one.)

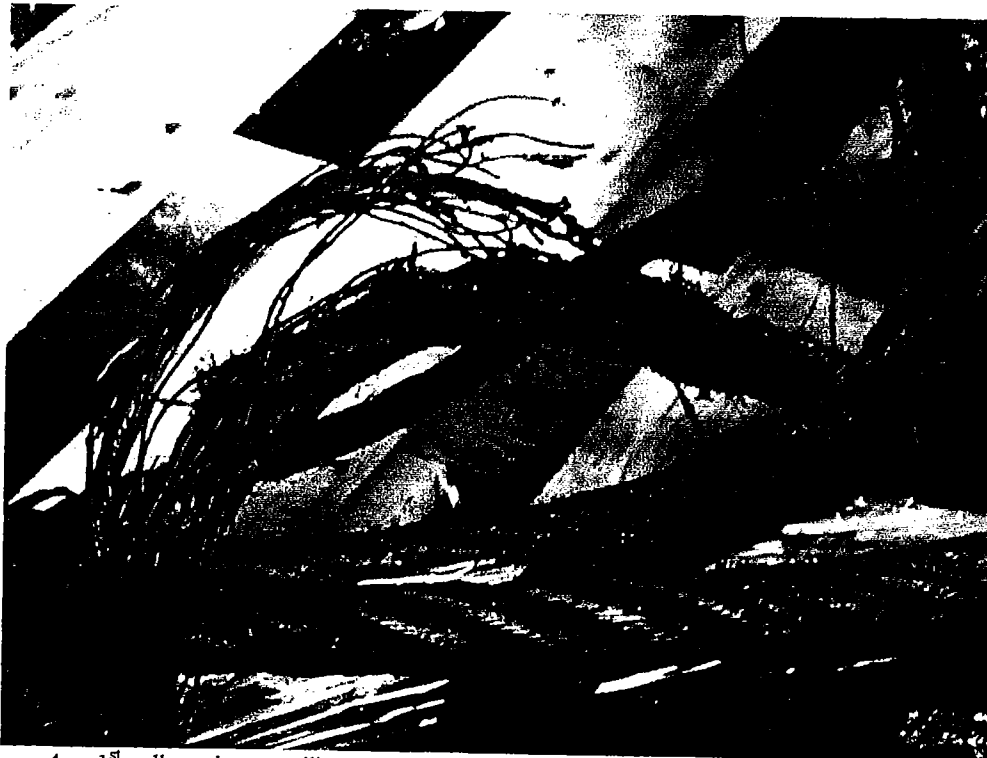
4. 1st pallet prior uncoiling with one of the broken ends, that broke apart at time of accident.

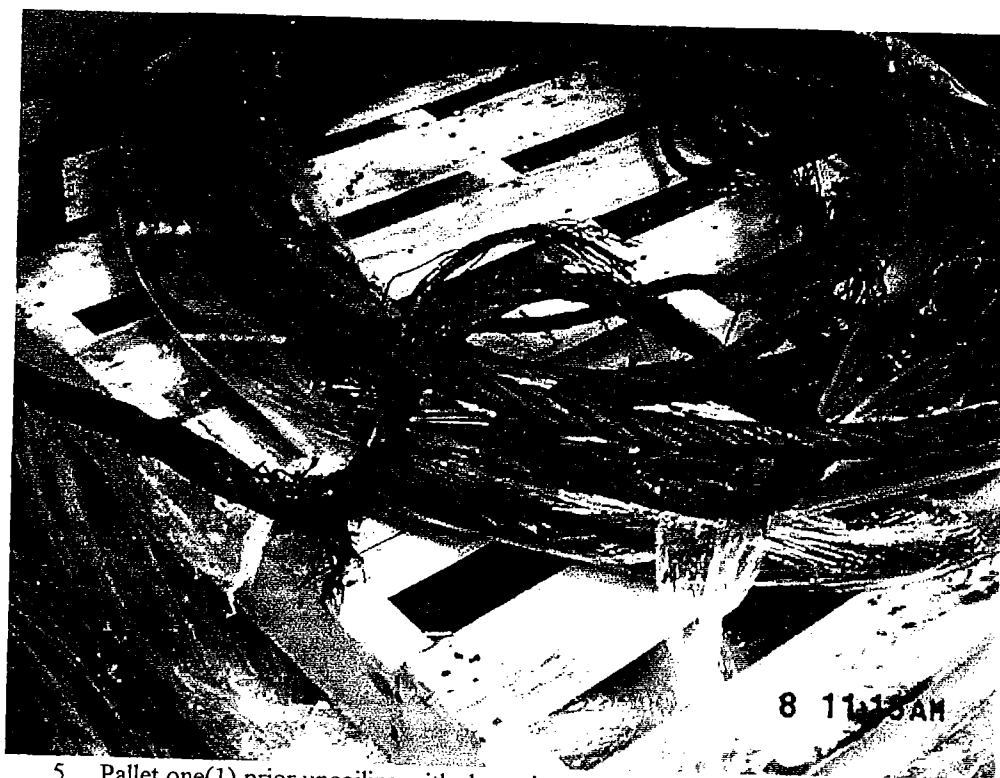
5. Pallet one(1) prior uncoiling with short piece at top. (USCG cut section)

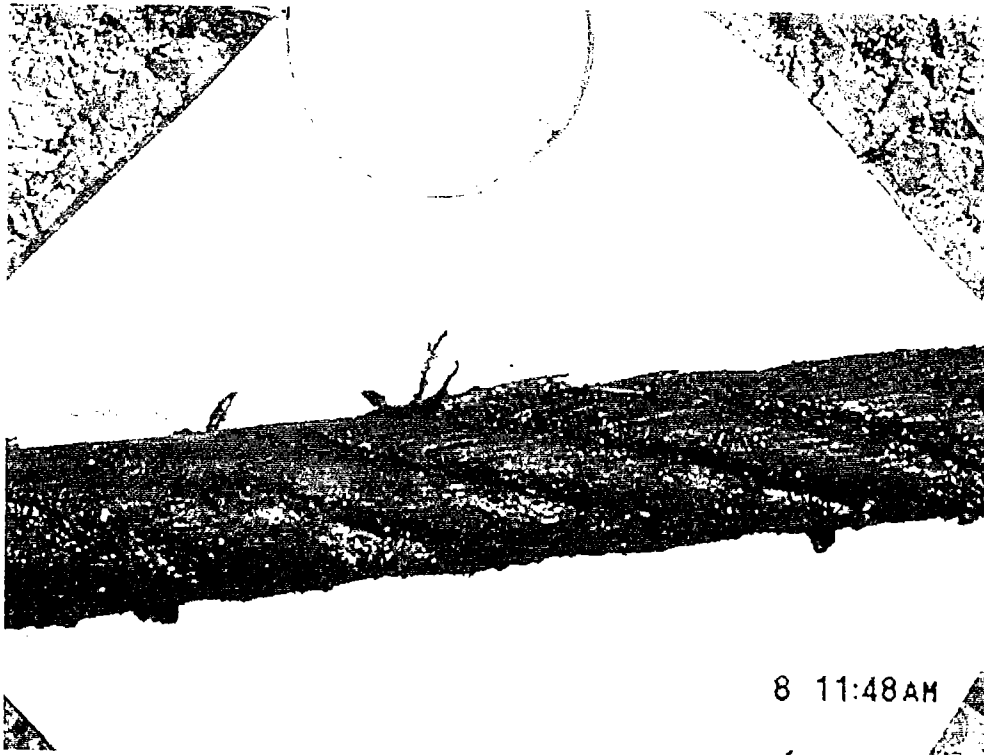
- An additional 11' short section was located at top of wire.
 - Wire was measured out and found as follows:
 - 63' 1" from socket, wire was found with breaks in one strand, appr. 10 individual wires were affected. (Nest type break pattern with wire ends bent and deformed)

7. 1 wire break area 63'01" from socket end.

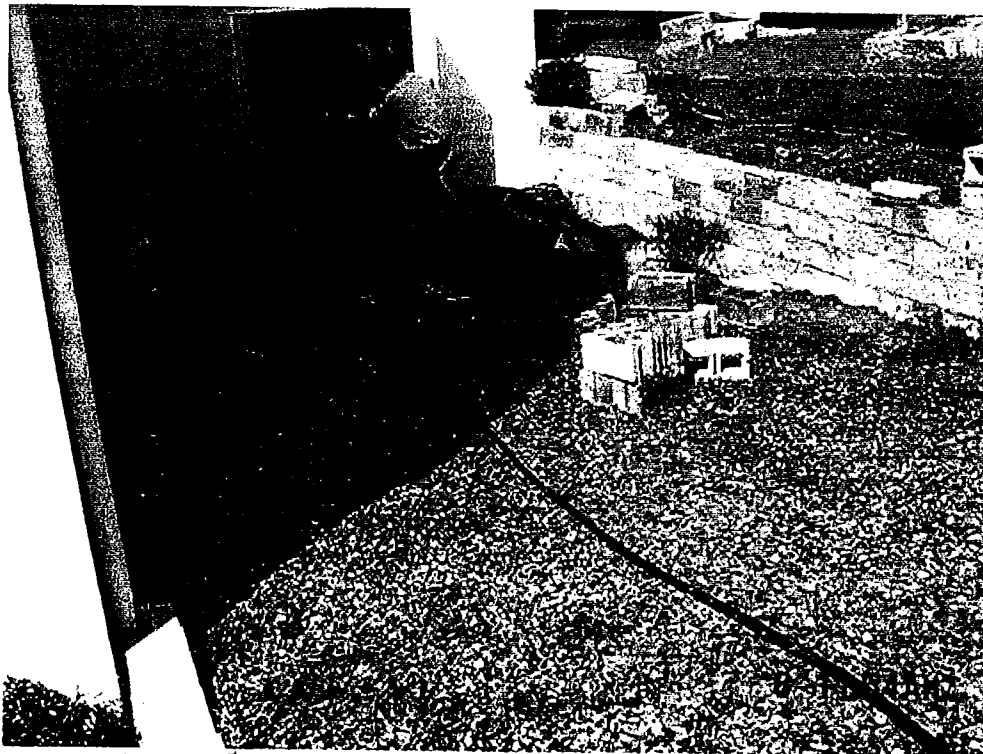
8. Wire from 1st pallet was run out over stone chip area.

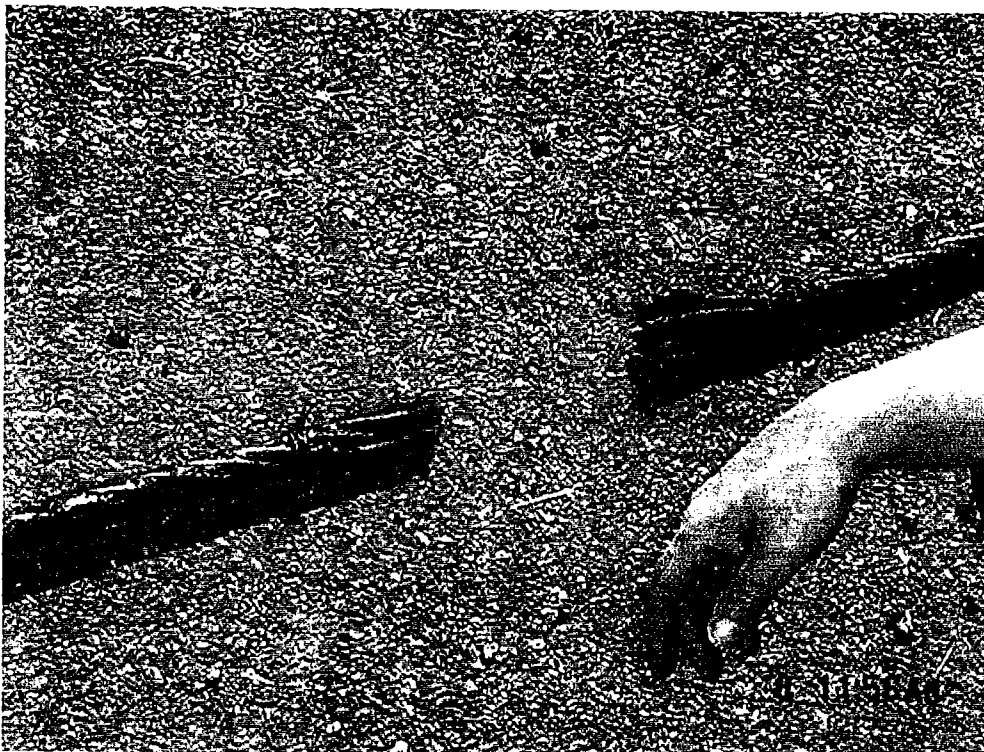
9. End of large wire from 1st pallet with cut end in front of actual break. Missing wires had been placed to prevent un-raveling of wire. (Cut was done at time of removing wire from vessel)

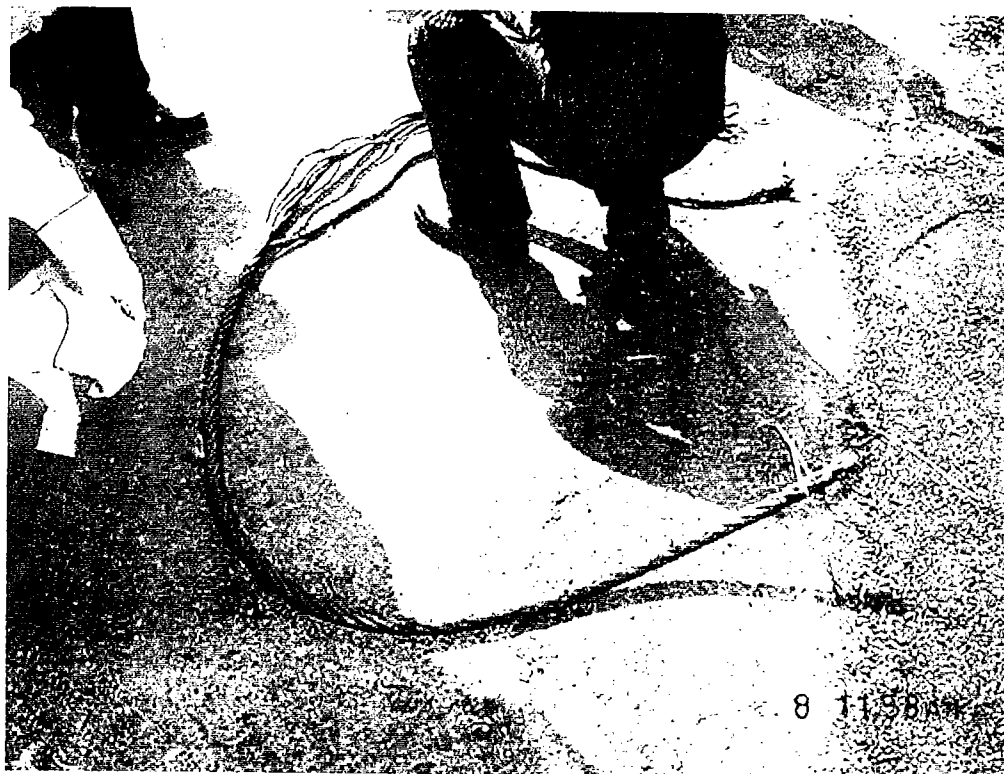
11. USCG cut section with one end with unraveled strands and broken wires.

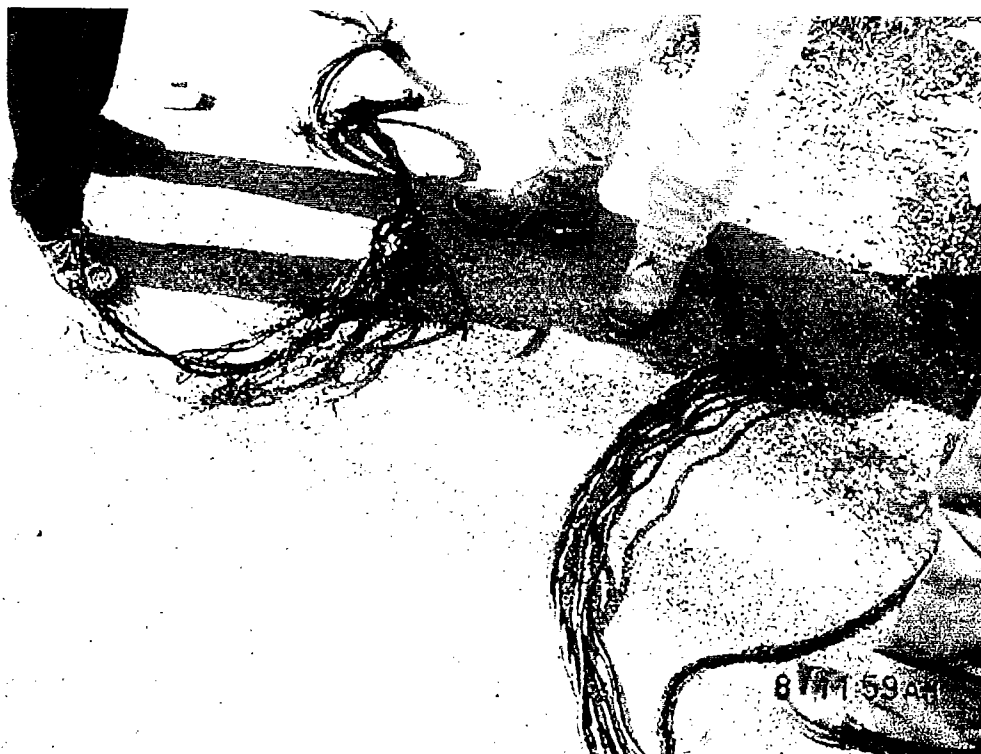
12. The two (2) short sections with the unraveled ends that matched break pattern.

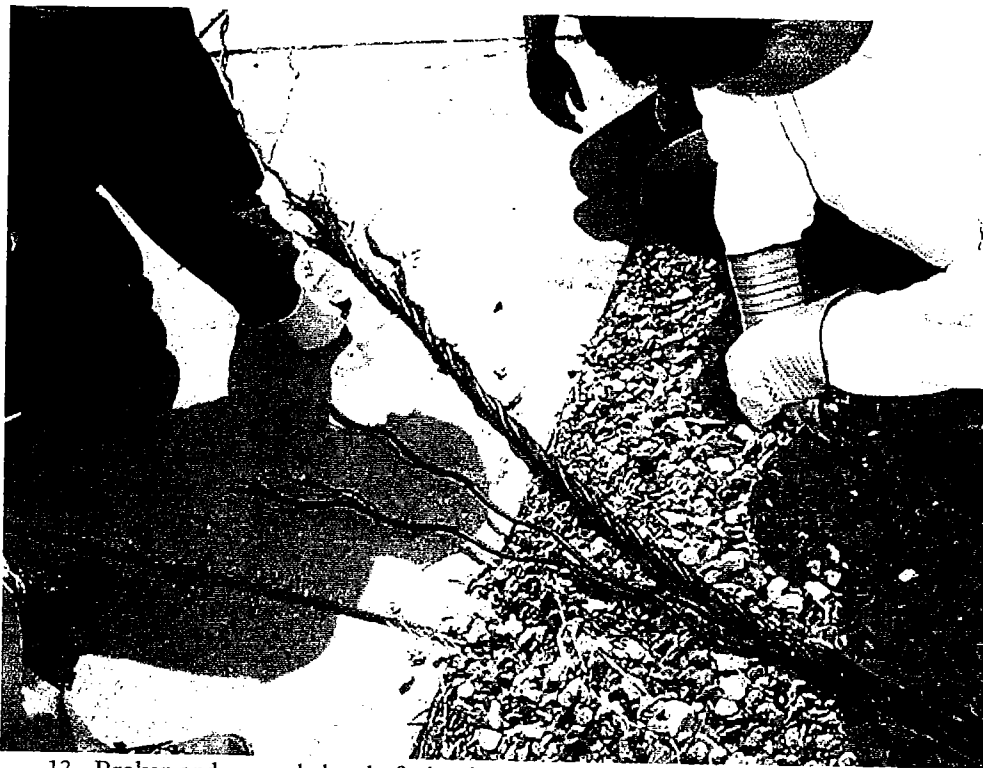
13. Broken and unraveled end of wire that was caused at time of accident.

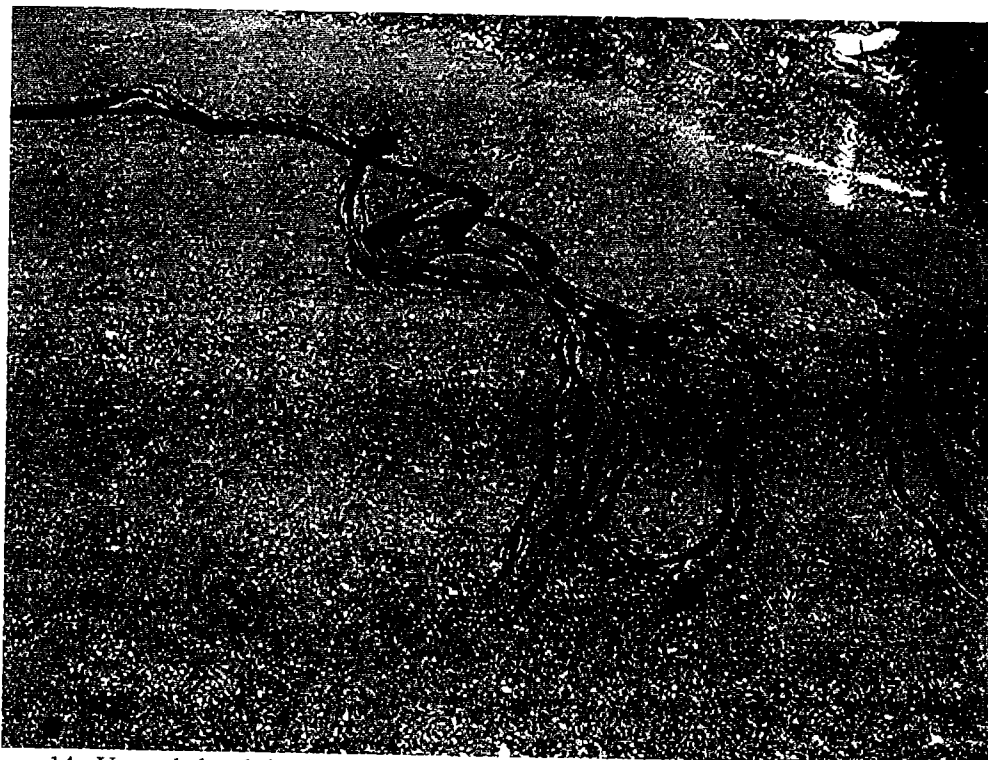
14. Unraveled ends in close up

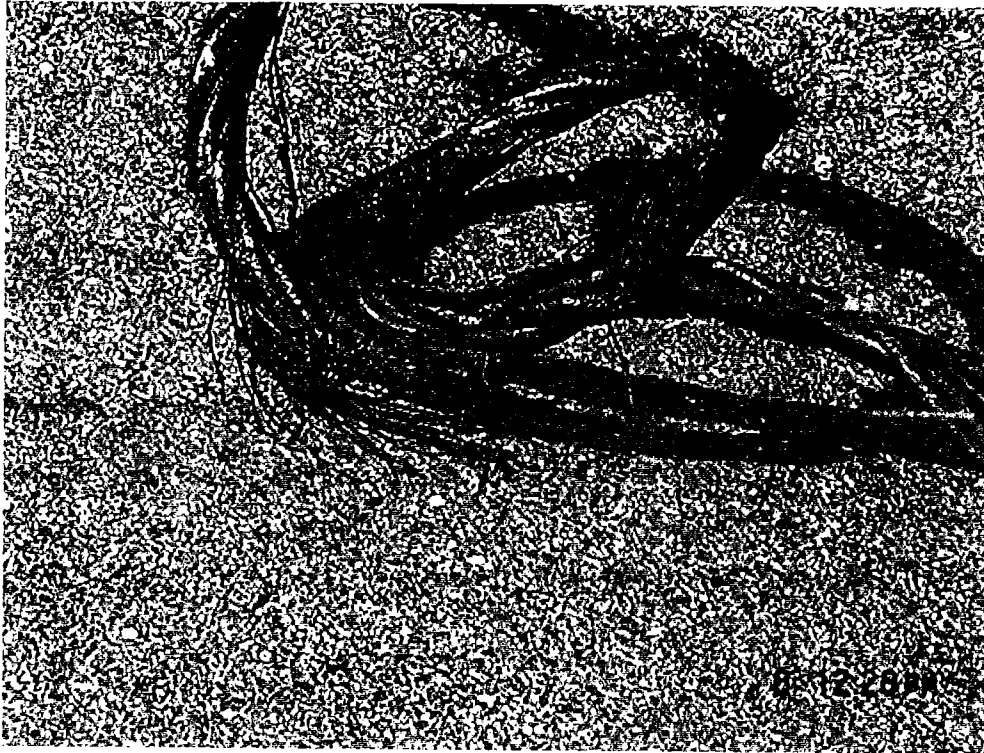
- Cut end to start of curling: 6' 08", curling to unraveled and broken strand area: 5'
- 3a. 3rd pallet contained approximately 114' 07" of wire. Wire was not opened up.

15. Short wire that matched cut end from 1 pallet long wire section had a strait end and than a kinked area prior area of wire failure.

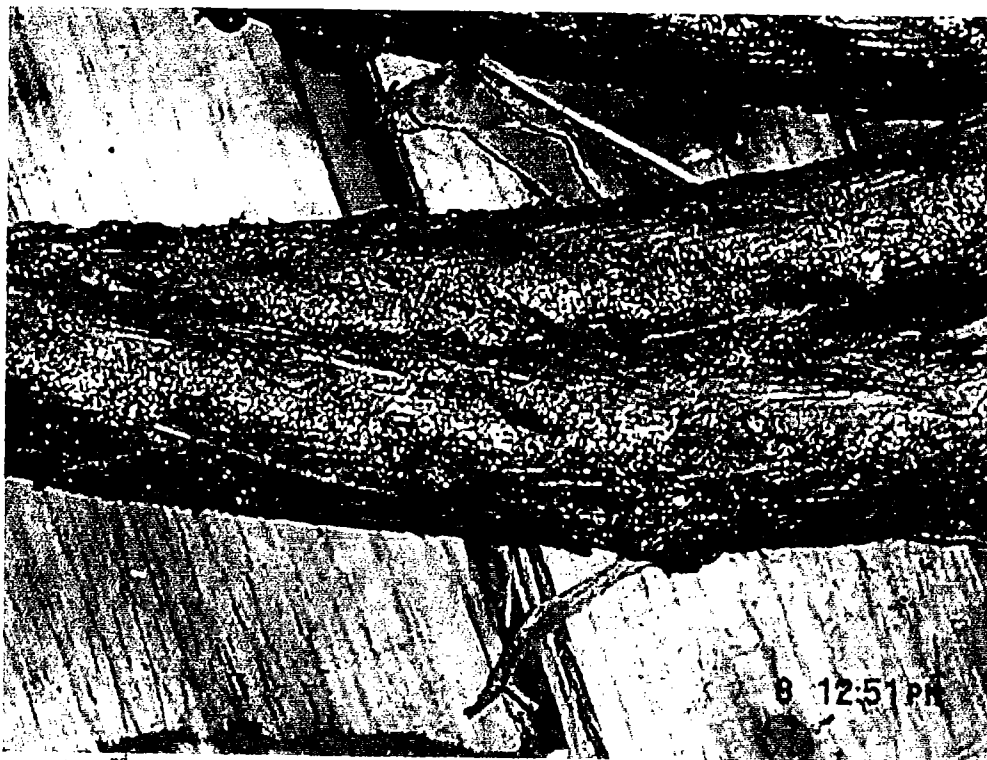
17. 2nd nest of broken wires within wire located on 2nd pallet.

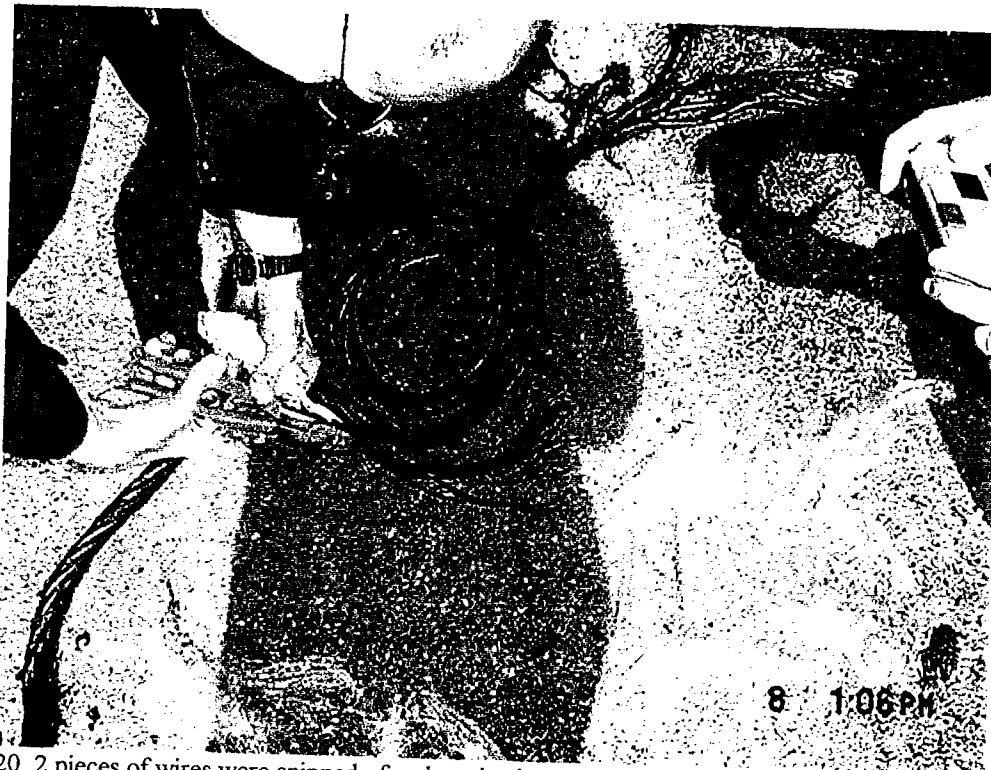
20. 2 pieces of wires were snipped of and retained as samples.
